# **INDOOR AIR QUALITY ASSESSMENT**

**Gardner Middle School  
297 Catherine Street  
Gardner, Massachusetts**

Prepared by:  
Massachusetts Department of Public Health  
Bureau of Environmental Health Assessment  
August, 2003

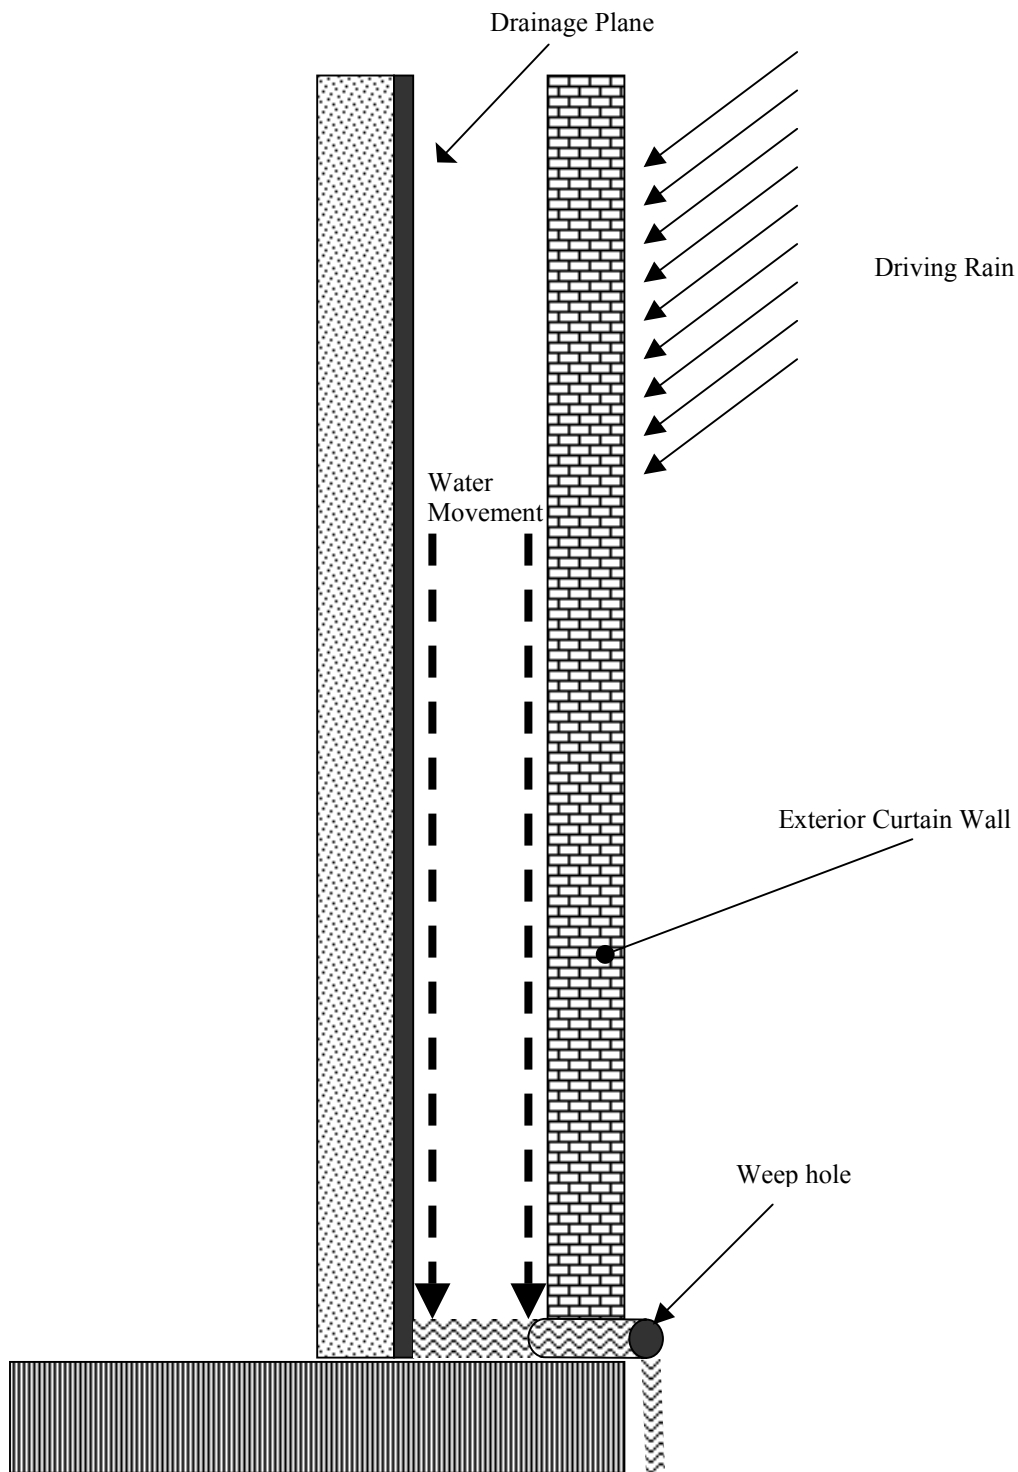
**Figure 2**  
**The Function of the Drainage Plane and Weep Holes to Drain Water from the Wall System, Prevent Moisture Penetration into the Interior**

Exterior wall systems should be designed to prevent moisture penetration into the building interior. An exterior wall system should consist of an exterior curtain wall (Figure 2). Behind the curtain wall is an air space that allows for water to drain downward and for the exterior cladding system to dry. At the base of the curtain wall should be weep holes that allow for water drainage. Opposite the exterior wall and across the air space is a continuous, water-resistant material adhered to the back up wall that forms the drainage plane.

In order to allow for water to drain from the exterior brick wall system, a series of weep holes is customarily installed at or near the foundation slab/external wall system junction (Figure 2). Weep holes allow for accumulated water to drain from a wall system (Dalzell, 1955). Failure to install weep holes in brickwork or burial of weep holes below

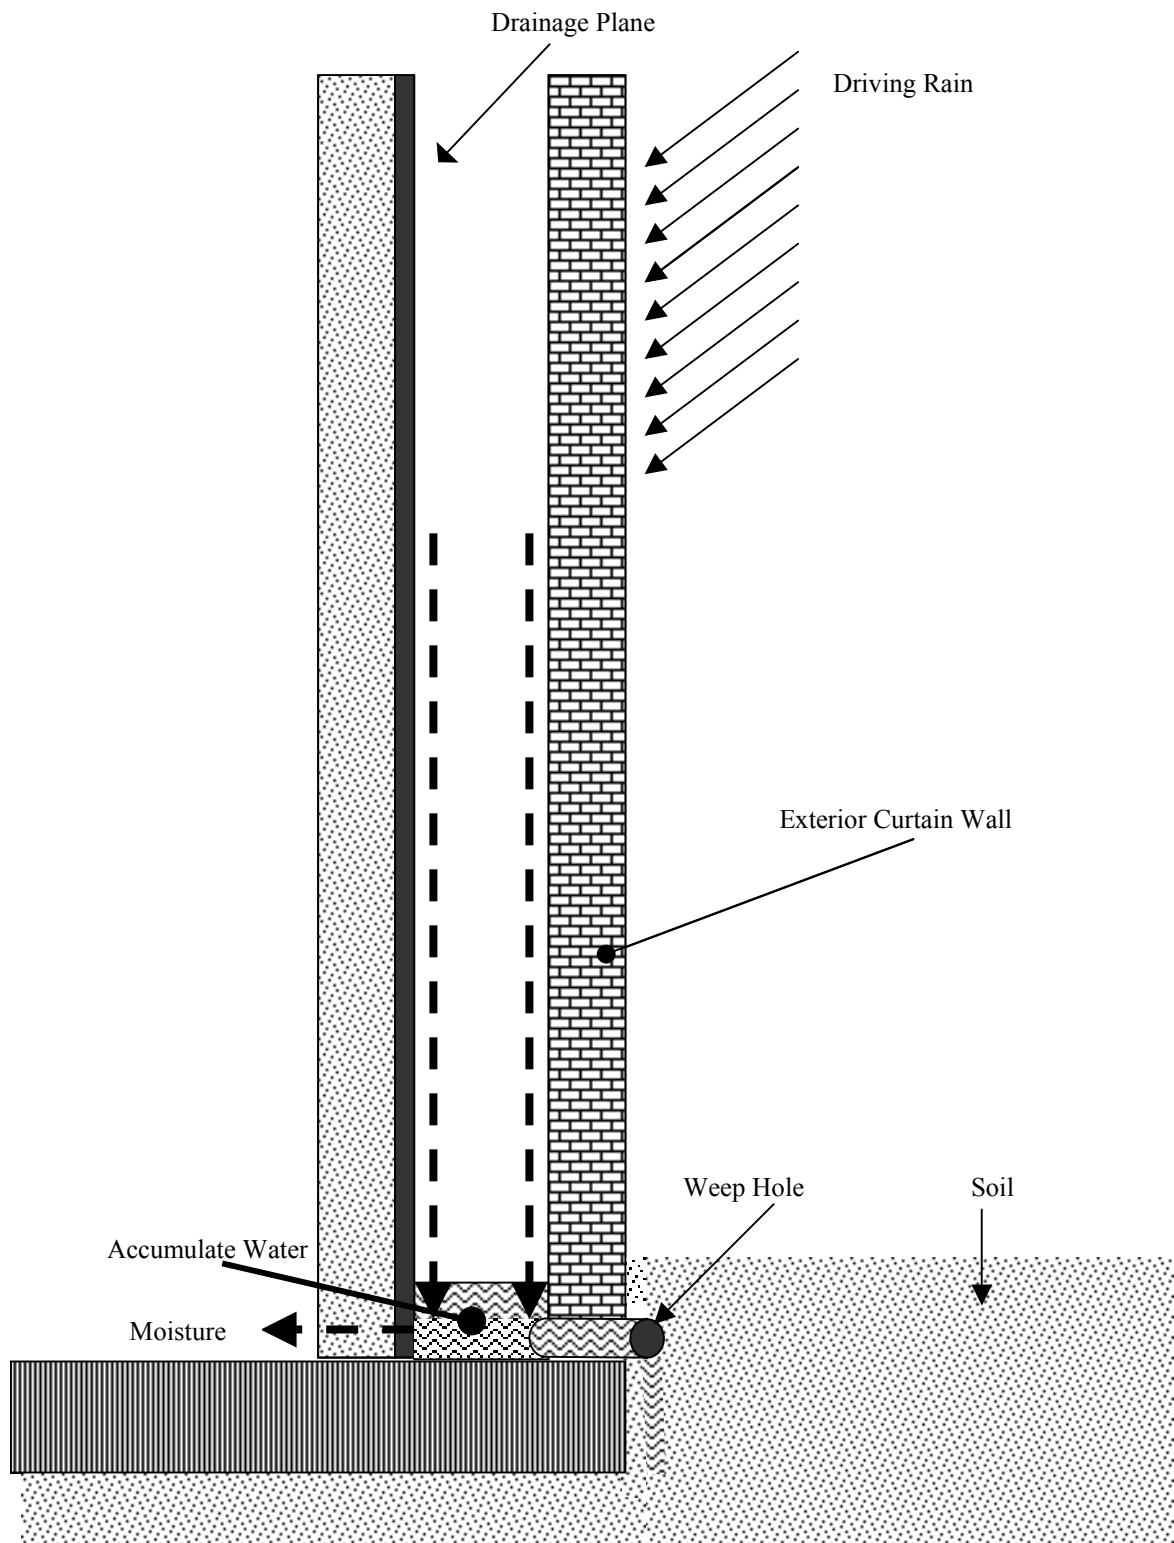
**Figure 3**  
**Weep Hole Blocked with Wick and Water Accumulation in the Drainage Plane**

grade will allow water to accumulate in the base of walls, resulting in seepage and possible moistening of building components (Figure 3).
